# MOODY METHODIST CHURCH

## 2021 MOODY STEEPLE CLADDING REPAIRS

### WEEKLY FIELD REPORT No. 02

### WEEK OF 1/25/2021

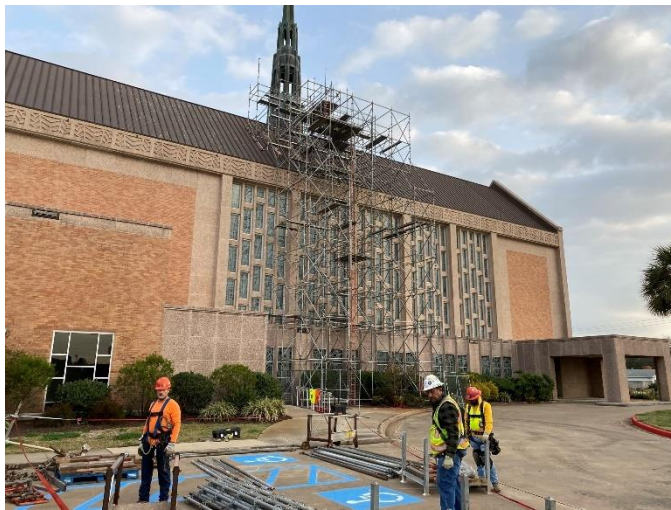
Photo01: Scaffolding Being Assembled on Roof

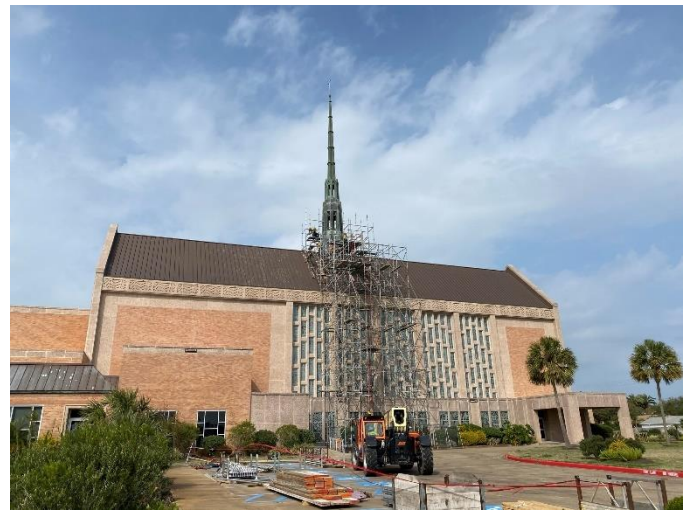
Photo02: Scaffolding Being Assembled

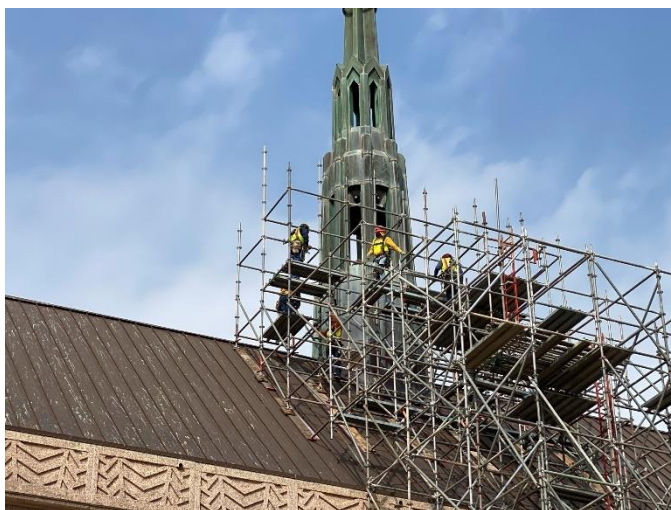
Photo03: Scaffolding Being Assembled

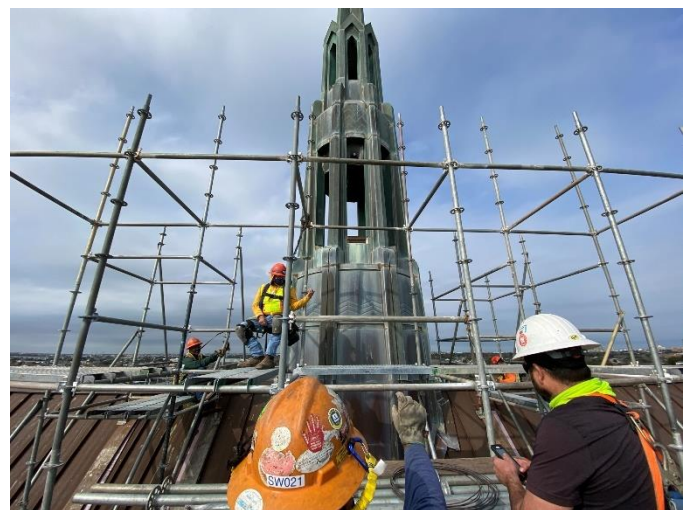
Photo04: Scaffolds Assembled Around Steeple

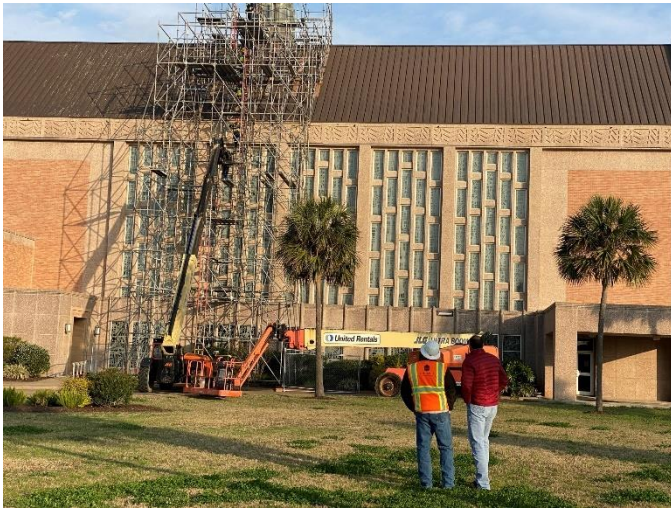
Photo05: Telescopic Boom Lift Brought on Site

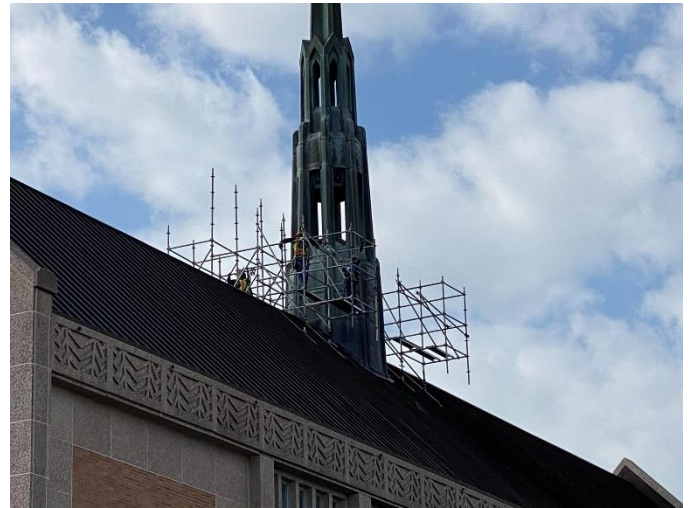
Photo06: Scaffolding Being Assembled

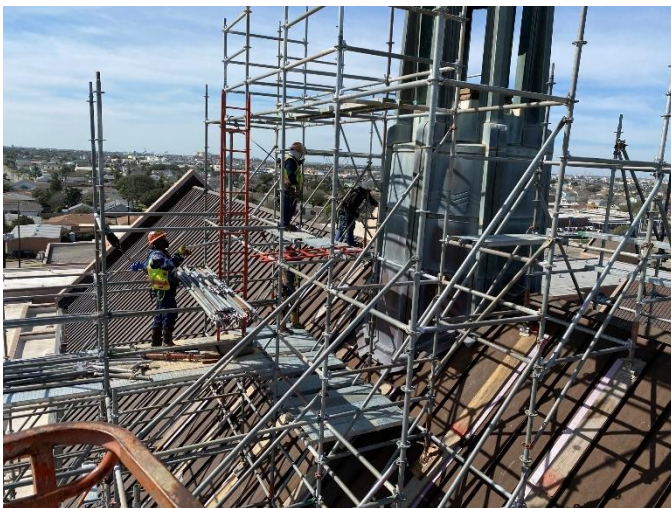
Photo07: Scaffolding Being Assembled

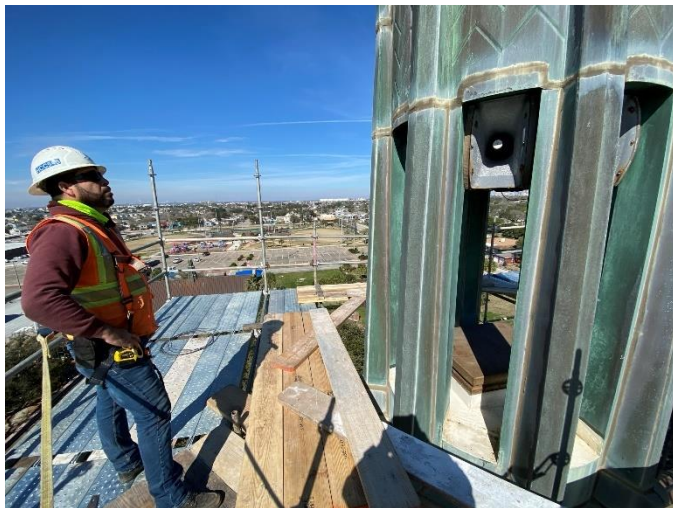
01 28-02 **RB Hash** on site to inspect condition of steeple. (*see photo08*)

Photo08: RB Hash Foreman Inspecting Copper Conditions

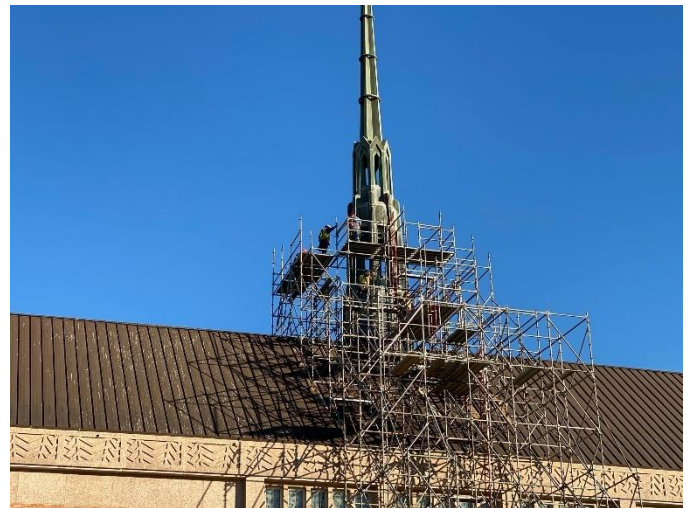
Photo09: Scaffolding Near Completion

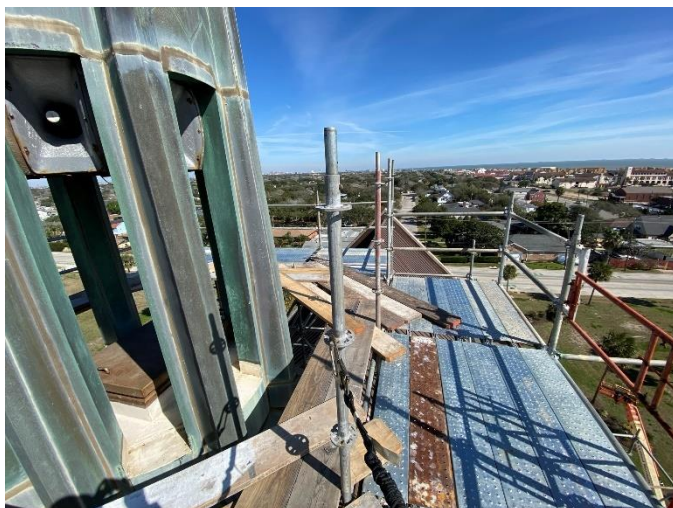
Photo10: Completed Scaffolding

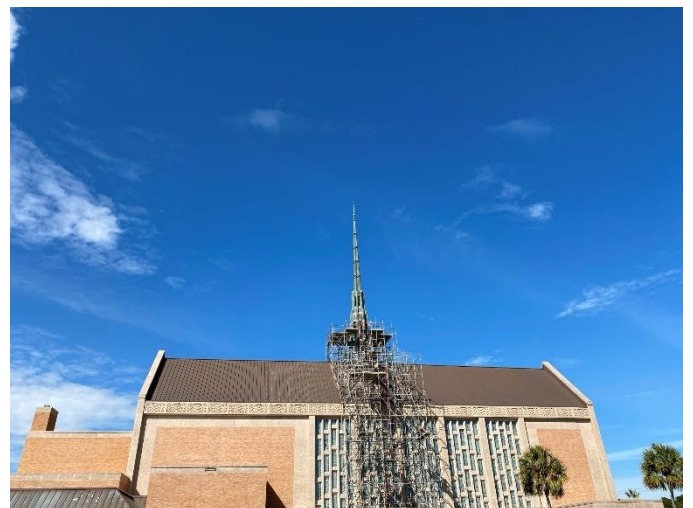
Photo11: Completed Scaffolding
