MOODY METHODIST CHURCH

2021 MOODY STEEPLE CLADDING REPAIRS

WEEKLY FIELD REPORT No. 19

WEEK OF 5/24/2021

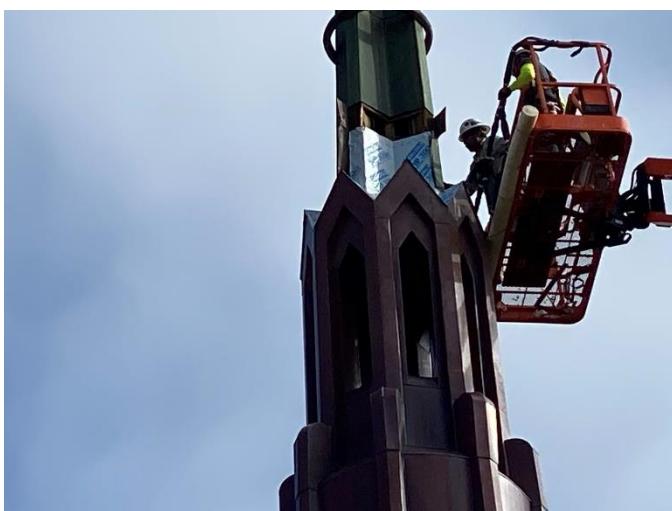
Photo01: Workers Removing Temporary Waterproofing and Copper Cladding of Spire

On Site:	Coltzer Company, LLC	Temperature – Low/High (°F):	79/84
	RB Hash	Rain (Total Inches):	0.00
		Max Wind Speed(mph):	12 SSE
Field Note:	Comments & Photographs:		
05 26-01	<i>Coltzer Company, LLC</i> on site to observe steeple repairs progress.		
05 26-02	<i>RB Hash</i> removes more copper cladding from the spire on top of the steeple. Wooden boards are removed, so only the steel structure remains. Marine grade plywood is measured and cut to replace the old wooden boards. <i>(see photo01-04)</i>

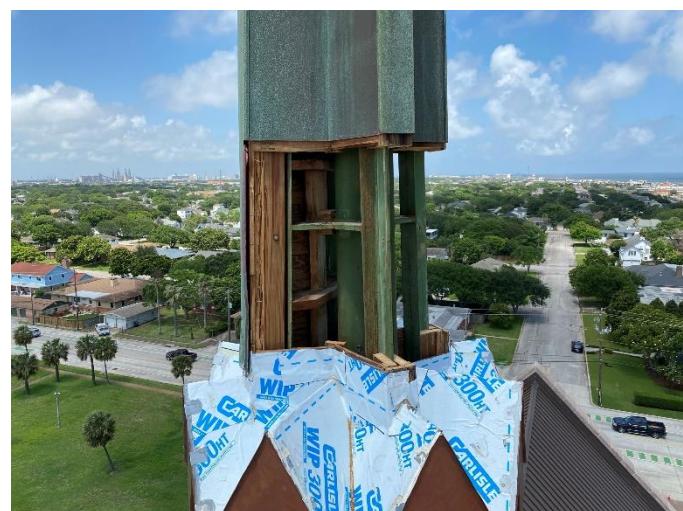
Photo02: Old Wooden Boards are Removed

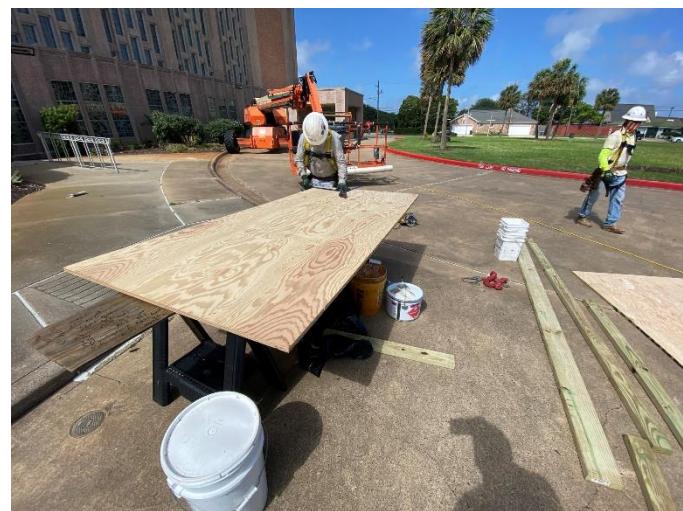
Photo04: Marine Grade Plywood Measured and Cut for Installation

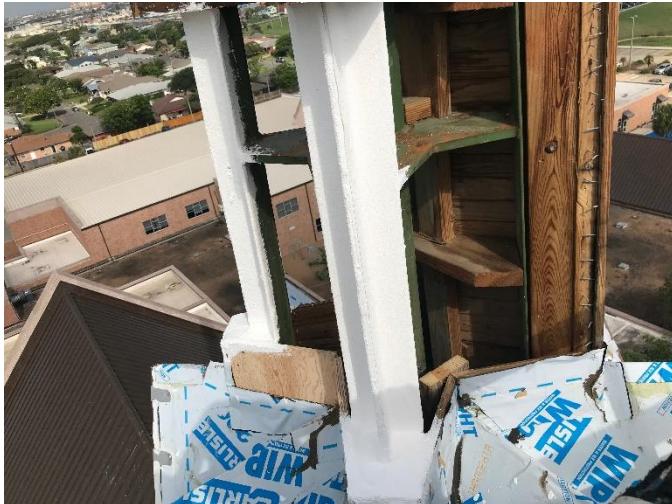
Photo05: Steel Structure Coated in Liquid Waterproofing

On Site:	Coltzer Company, LLC	Temperature – Low/High (°F):	79/84
	RB Hash	Rain (Total Inches):	0.00"
		Max Wind Speed(mph):	15 S
Field Note:	Comments & Photographs:		
05 27-01	<i>Coltzer Company, LLC</i> was onsite to observe steeple repair progress.		
05 27-02	<i>RB Hash</i> coats the exposed steel structure of the spire with a protective layer of waterproofing. New wooden boards and marine grade plywood are fastened to the steel structure. (see photo05-08)

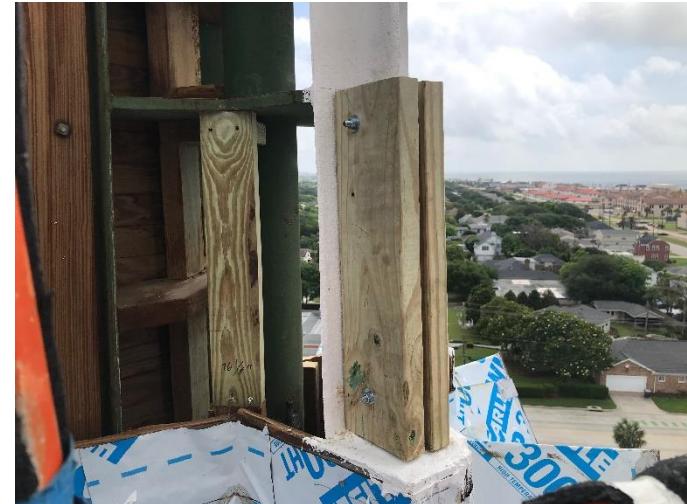
Photo06: New Wooden Boards are Installed on the Steel Structure

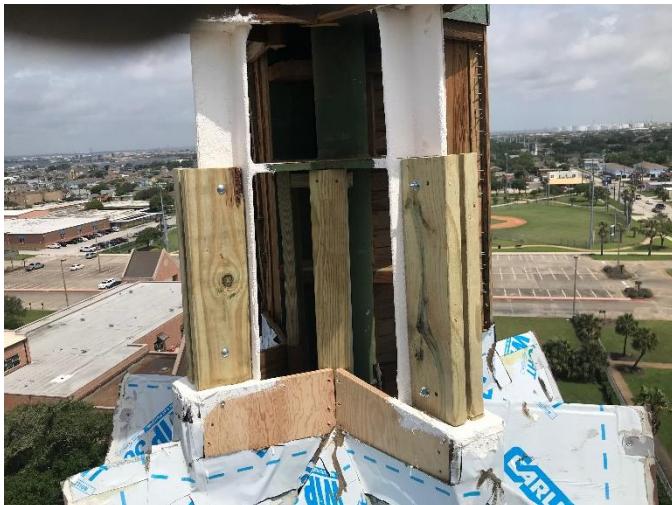
Photo07: New Boards Fastened to the Steel Structure

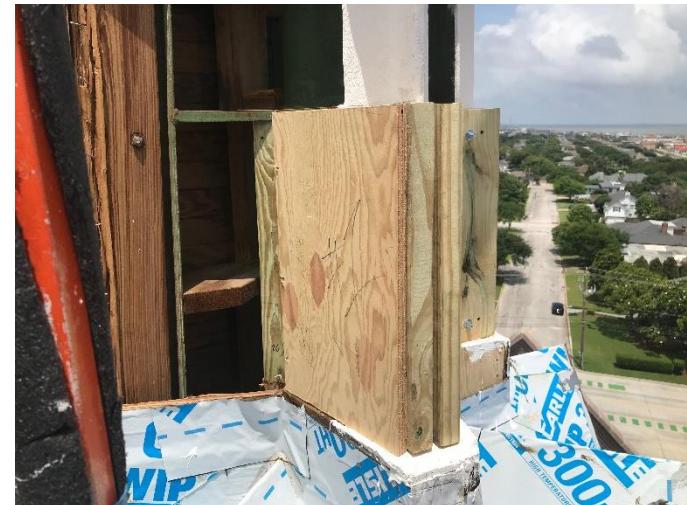
Photo08: Plywood Fastened to Boards and Steel Structure

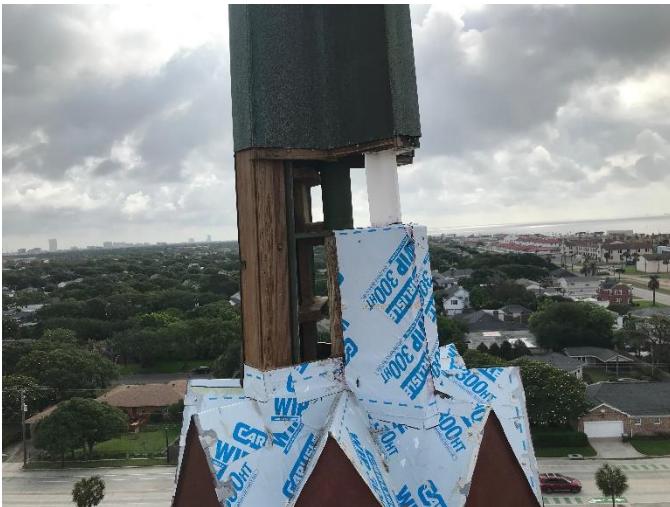
Photo09: Waterproofing Installed on New Plywood and Boards

On Site:	Coltzer Company, LLC	Temperature – Low/High (°F):	79/84
	RB Hash	Rain (Total Inches):	0.00"
		Max Wind Speed(mph):	17 E
Field Note:	Comments & Photographs:		
05 28-01	<i>Coltzer Company, LLC</i> was onsite to observe steeple repair progress.		
05 28-02	<i>RB Hash</i> installs waterproofing on the new wooden boards and plywood in the spire. A new piece of marine grade plywood is installed adjacent to the previously installed plywood. (see photo09-10)

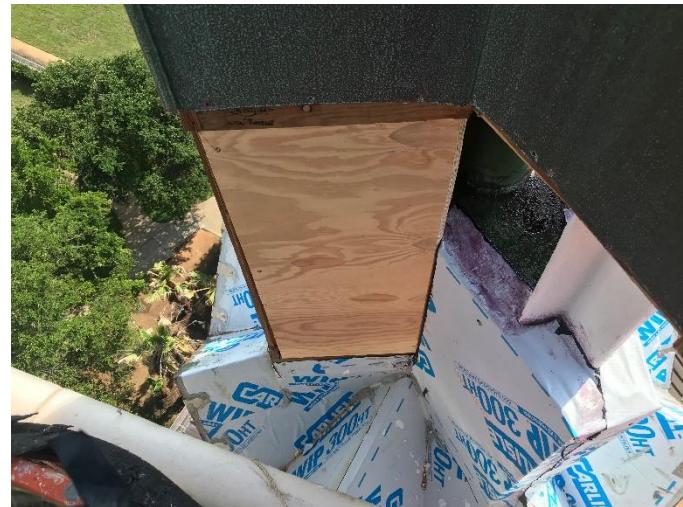
Photo10: New Plywood Piece Installed Adjacent to Newly Waterproofed Plywood and Boards
